RELIABILITY IMPROVEMENT WARRANTY (RIW) MID CONTRACT EVALUATION. (U)

NOO383-73-C-3318

**REPORT NUMBER:- ASO-TEE-2-77**

Prepared by: Oscar Markowitz PE, CPL

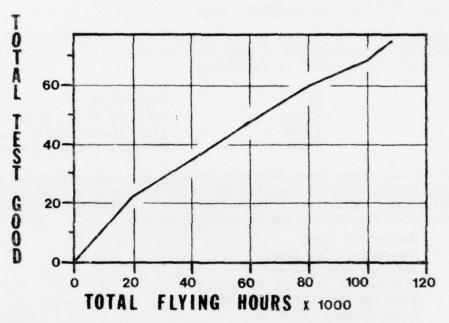
FIGURE 8: Flight Hours and Test Good Returns

1. "Test Good" (77 returns): It is the nature of hydraulic systems to have problems with contamination. When the system becomes contaminated, the major components with no filter protection must be cleaned/purged and tested for damage. Since there is no field test stand available for this pump, then the pump must be returned to Abex for cleaning/purging and testing. The change in "Test Good" returns per flying hour becomes a measure of the general operation and maintenance performances within the fleet relative to the pump

and its interconnecting hydraulic systems. Figure 8 shows returns of "Test Goods" as related to flying hours. When a pump is removed for any other reason than direct knowledge of pump malfunction, the pump is returned to Abex for testing. Considerable confidence of pump performance has been built up by fleet operational and intermediate maintenance personnel because of the RIW contract field operations and high reliability. Thus, in most situations of hydraulic system inadequate performance, the pump would be among the last rather than the first component to be removed.

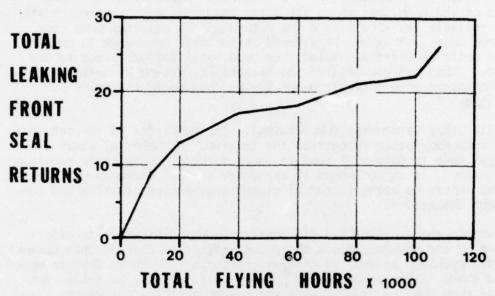
FIGURE 9: Flight Hours and Leaking Front Seal Returns

2. Front Seal Leak (26 returns): The normal characteristic of an engine driven pump is to leak at the front seal by a very small amount. From a design point of view, this minor leakage is necessary to provide lubrication to that rotating seal. The Abex pump specification permits 2 drops per hour of pump operation. It has also been normal history for all aircraft that a major reason for engine driven pump removals has been excessive leakage at a front seal. The Abex pump has not been an exception to this generic condition. This problem of returns was evident at the early stages of the RIW. Under the RIW, Abex critically reexamined the front seal design and quickly implemented changes to improve seal reliability. Figure 9 plots the returns due to excessive front seal leakage as a function of flying hours. This leaking seal problem has been complicated by potential front seal damage each time a drive spline is sheared when the output port quick disconnect coupling pops off (due to improper fastening during maintenance). The number of hours on a returned pump (average, to date) is estimated to be \$76 hours. There are many pumps which are flying and have never been removed. Thus, if the front seal is

in fact life limited, there can occur later a rash of returns for leaky front seals, within the time frame of the RIW. This characteristic will be monitored closely during the RIW contract to determine the actual long term improvements in this critical area.

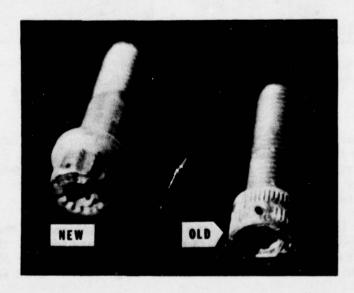
FIGURE 11: Old & New External Assembly Bolts

4. External Assembly Bolts: The original design used internal wrenching bolts which cost less initially (\$0.13 per unit), but after being torqued and later removed, lose their ability to be torqued accurately and must be replaced with new bolts. When the RIW became operative, Abex was quick to recognize that the more expensive (\$0.28 per unit), externally wrenched 12 point bolt was stronger, would wrench to a given torque in less time, more accurately and without requiring replacements after maintenance. Thus, Abex replaced the external assembly bolts to improve maintainability of the pump. The old and new bolts are shown in Figure 11.
